**MITIGATING BIOFILM GROWTH THROUGH THE
MODIFICATION OF CONCRETE DESIGN AND PRACTICE**

A Thesis
Presented to
The Academic Faculty

Georgia Institute of Technology

May 2008

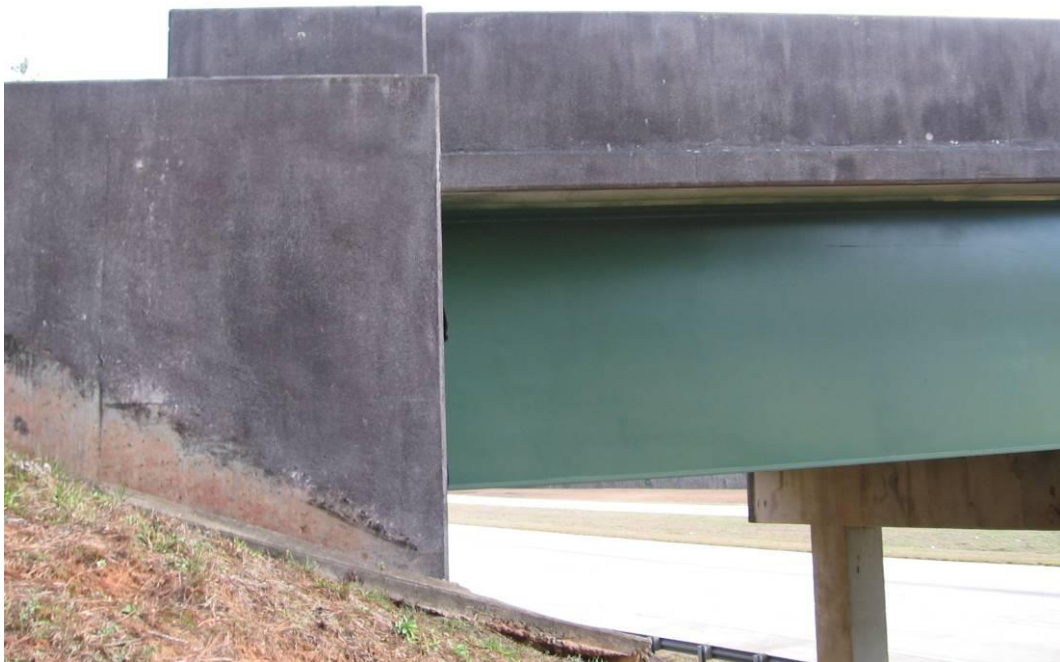
Figure 2.2 - Biodeterioration on concrete abutment near LaGrange, GA

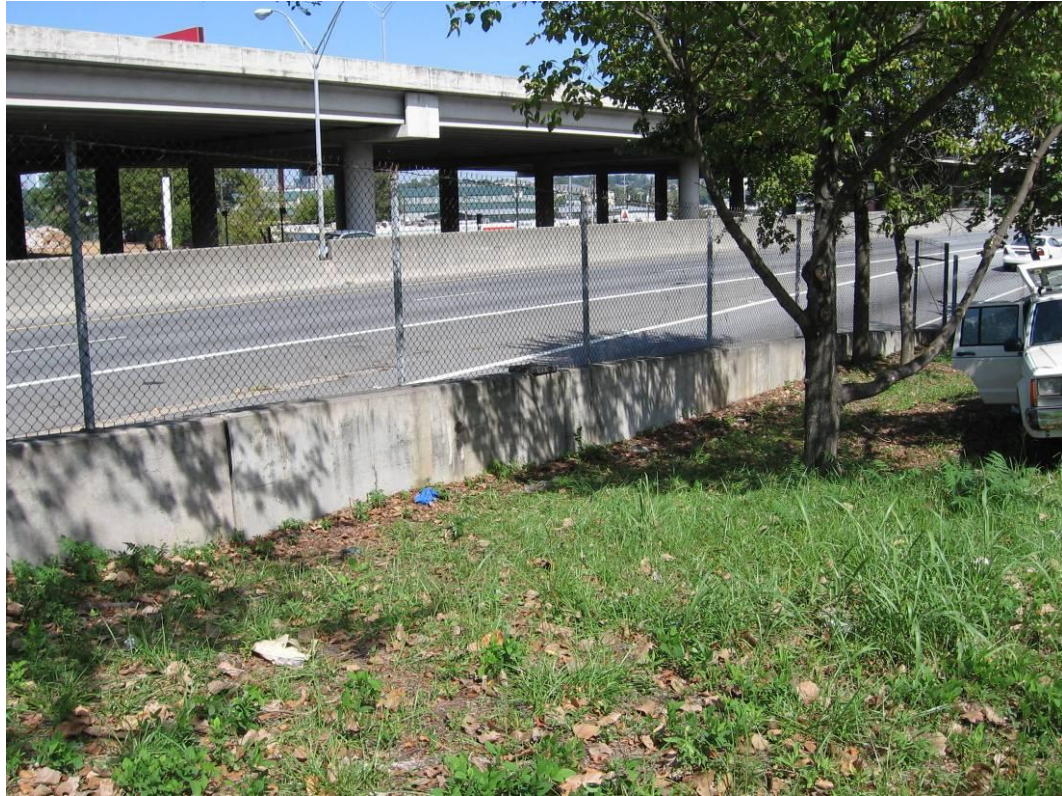
Figure 3.1 - Overview of Atlanta Site

The Atlanta site is located on GA-13 in Fulton County approximately 1000 ft south of GDOT bridge #121-0556-0. The concrete sampled was the south side of the barrier between GA-13 and Monroe Dr, as seen in Figure 3.1. A paint-like construction coating appeared to be covering the barrier. Figure 3.2 shows the uneven color and streaky nature of the biofilm. The biofilm could be removed easily by hand with a wire brush to reveal the concrete surface beneath.

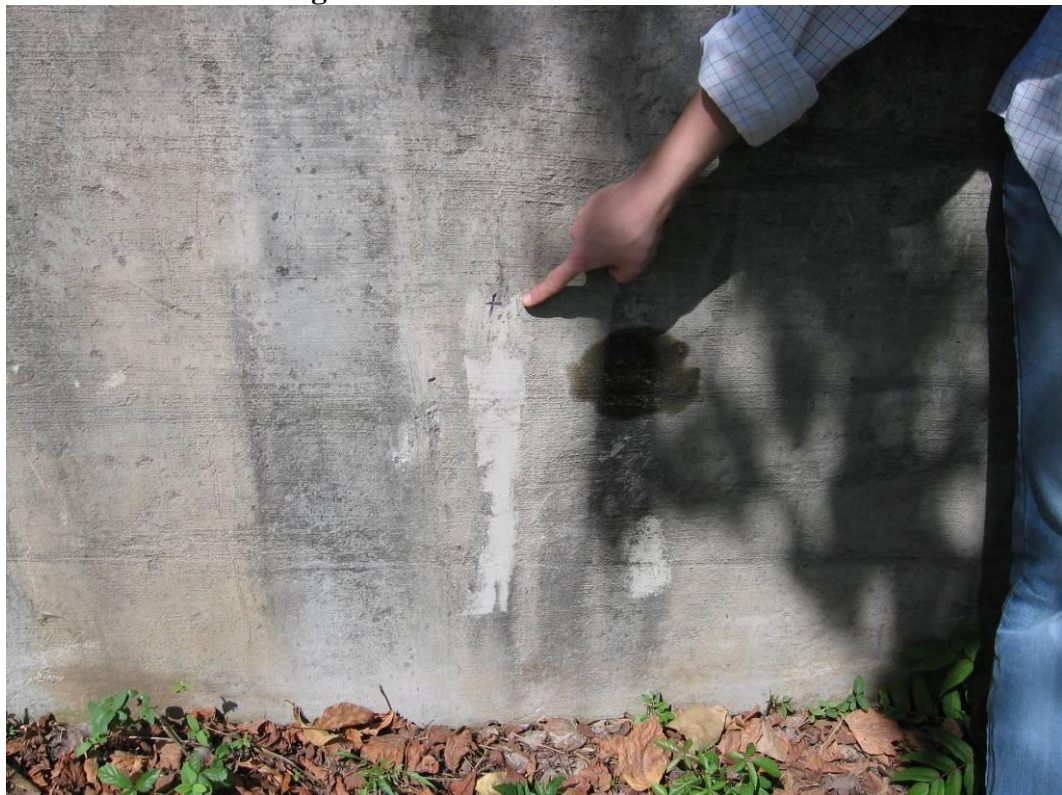
Figure 3.2 - Closeup of sampling location. Light color in the center of the picture is where biofilm has been removed by a wire brush

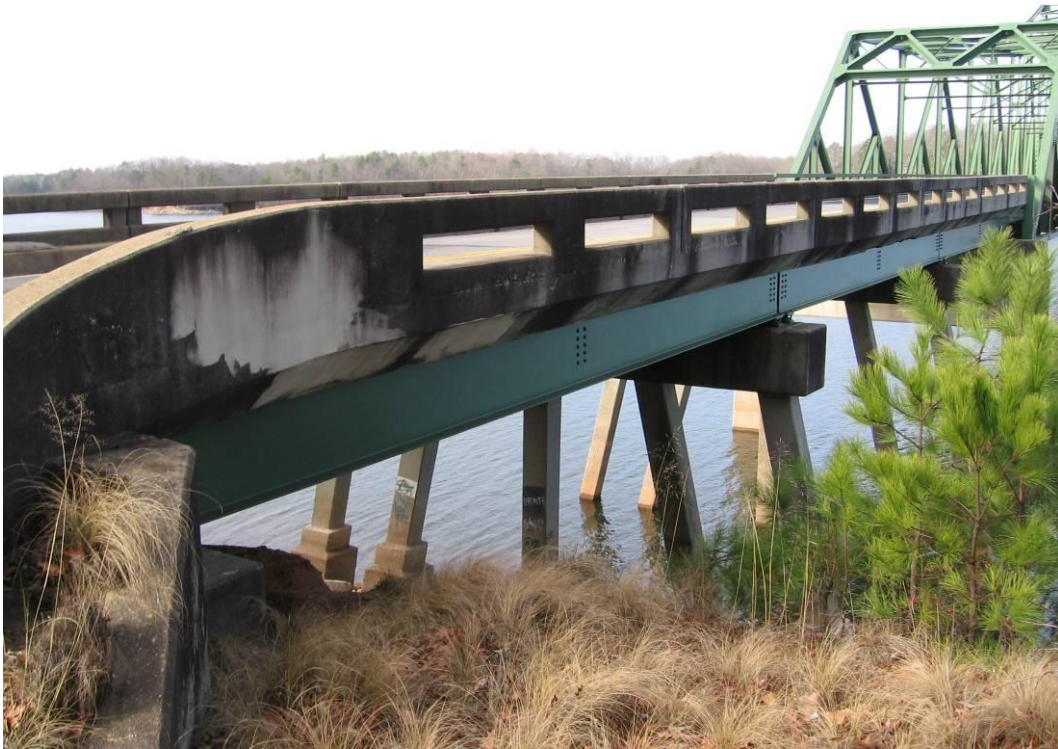
Figure 3.3 - Overview of Gainesville site, looking west over Lake Lanier

The Gainesville site is Brown's Bridge, GDOT bridge #117-0022-0, located on GA-369 and crossing Lake Lanier on the border of Hall County and Forsyth County. The biofilm sampled was on the concrete barrier on the east end of the bridge. The concrete was not covered by any painted coating. The biofilm coverage was heavier near the shore and dissipated as the bridge extended over the lake, as seen in Figure 3.3. The coverage on the south side of the bridge was generally lighter and streakier than the north side, as seen in Figure 3.4.

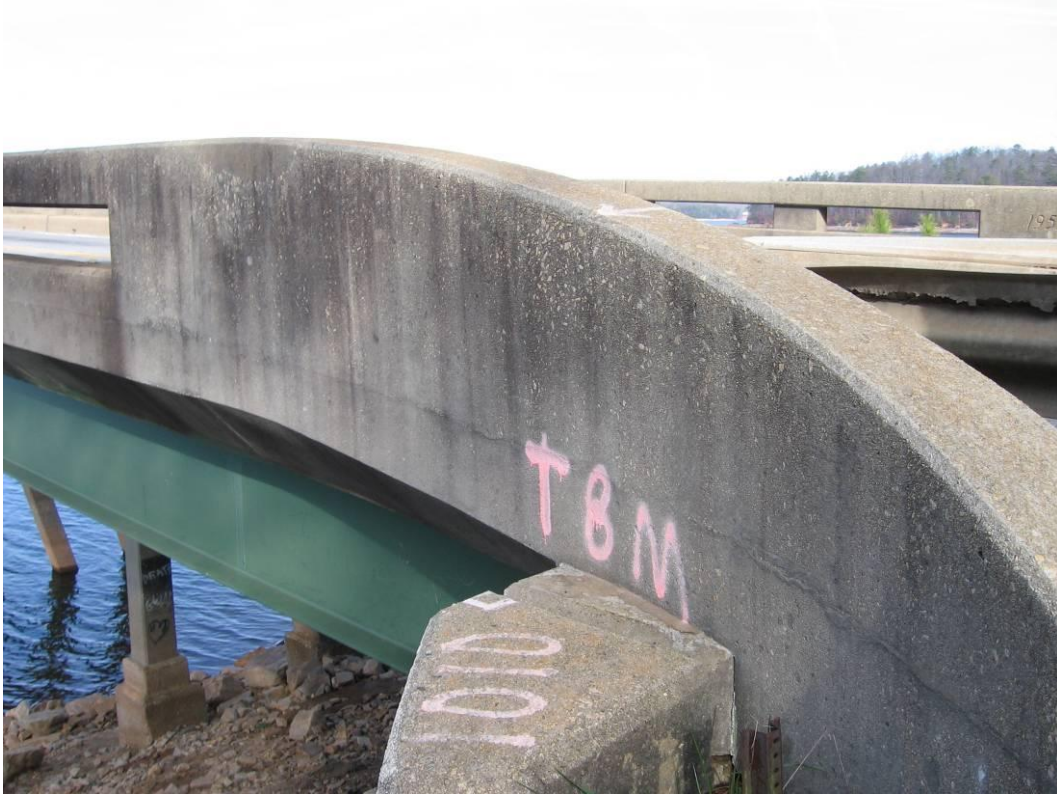
Figure 3.4 - Closeup of south side of bridge. Note streaky appearance of biofilm

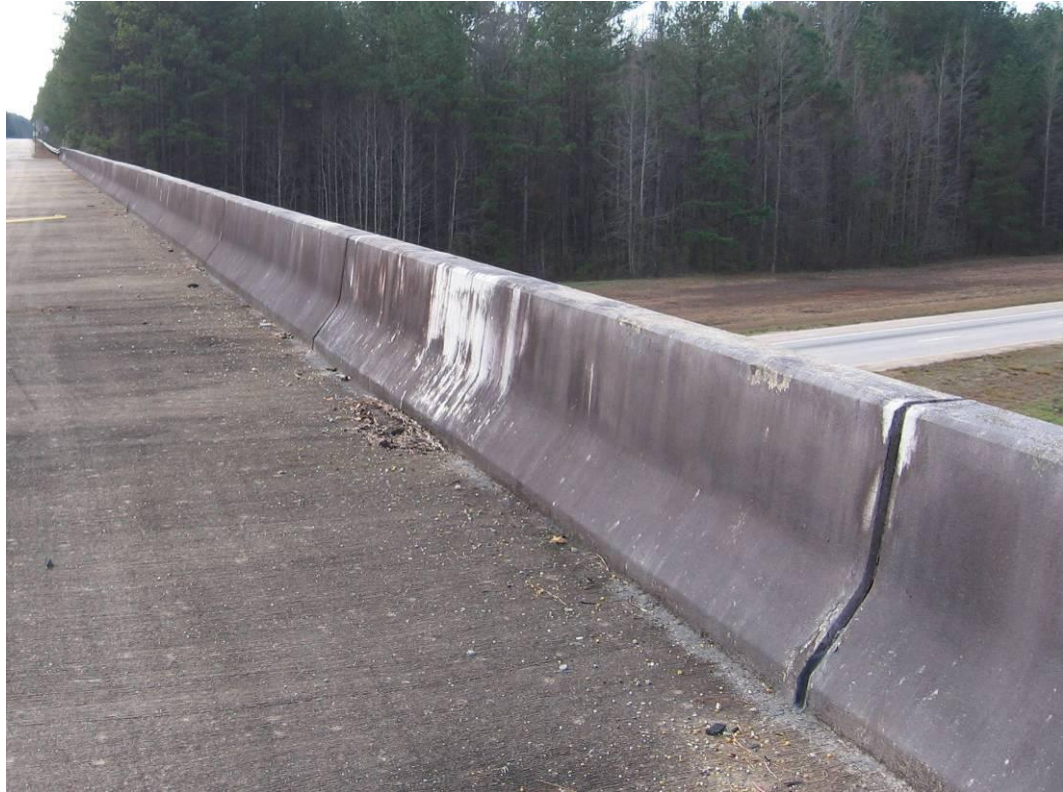
Figure 3.5 - Overview of LaGrange site, looking south at the west barrier of the bridge

The LaGrange site is located in Troup County on the bridge for the northbound lanes of I-185 to southbound I-85, GDOT bridge #285-0027-0. This site had the darkest and most uniform coverage of biofilm of all the sites visited, as seen in Figure 3.5. The concrete barriers appeared to be coated with a paint-like construction coating. The coating on the top of the concrete barrier appeared eroded but was not easily removed by a wire brush, as seen in Figure 3.6. The biofilm had a purplish hue and was easily removed with a wire brush.

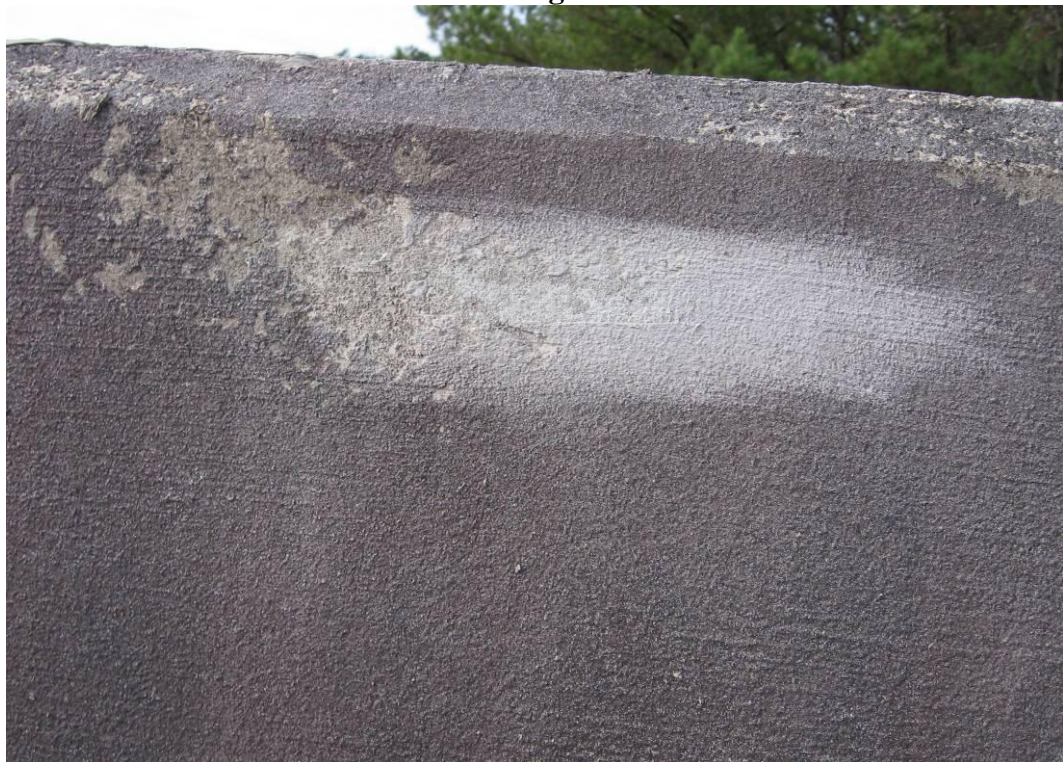
Figure 3.6 - Closeup of barrier. The light area has been scraped by a wire brush. Notice the deterioration of coating in the top right of the picture

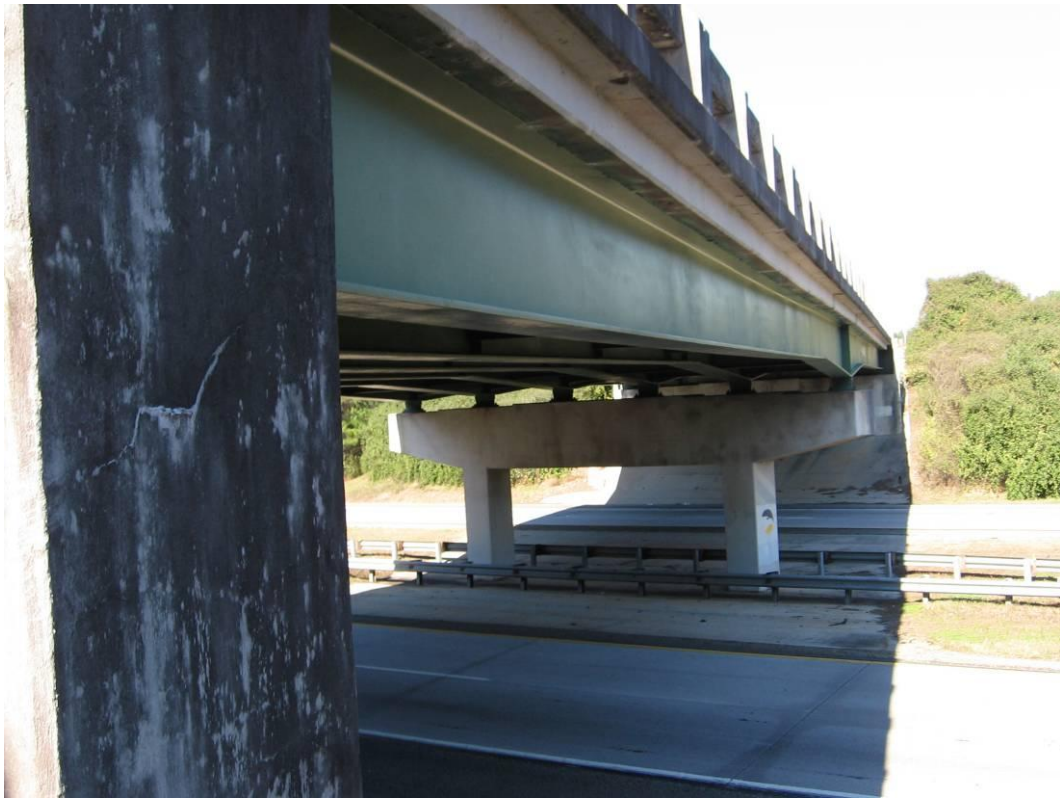
Figure 3.7 - Overview of Savannah site. The abutment sampled is immediately to the left of the image

The Savannah site is located in Bulloch County, on the bridge for Ash Branch Church Rd over I-16, GDOT bridge #031-0089-0. The concrete for the abutment on the south side of the bridge was sampled at this site and was covered with a paint-like construction coating. The coating on this bridge showed the worst deterioration of all sites visited. Large portions of the coating were delaminating and flaking off the abutment. The concrete beneath the delaminated coating was covered in biofilm but did not appear to be deteriorated.

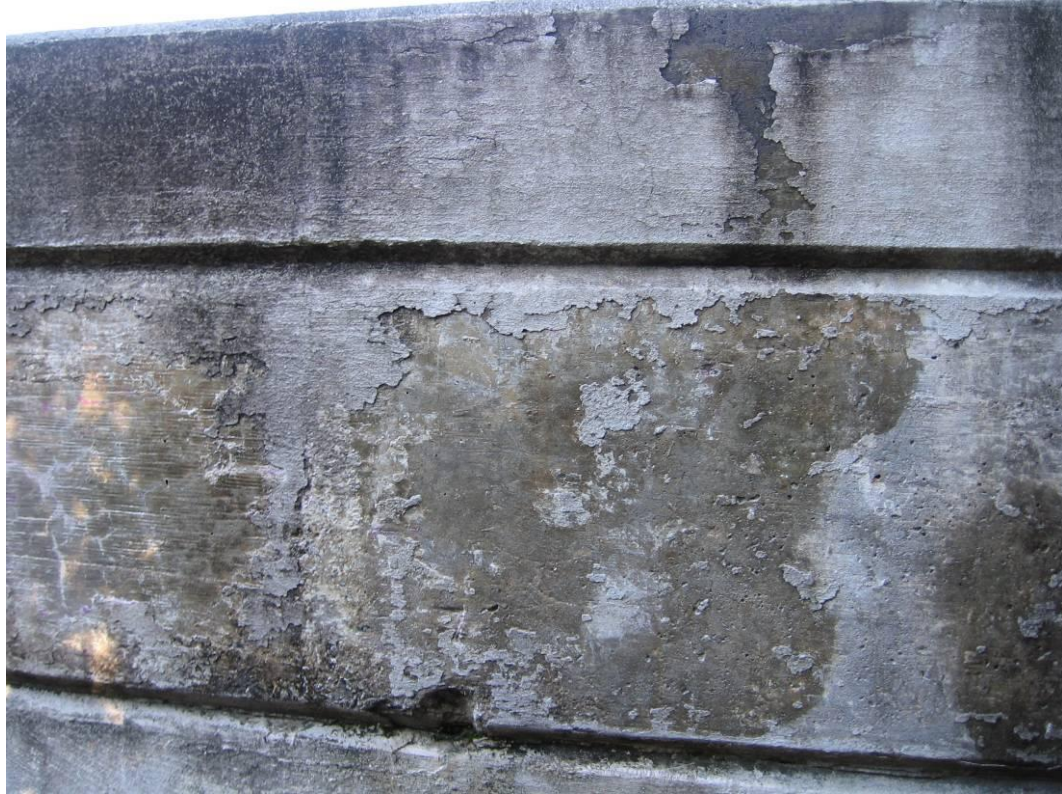
Figure 3.8 - Closeup of abutment. Notice deteriorated coating

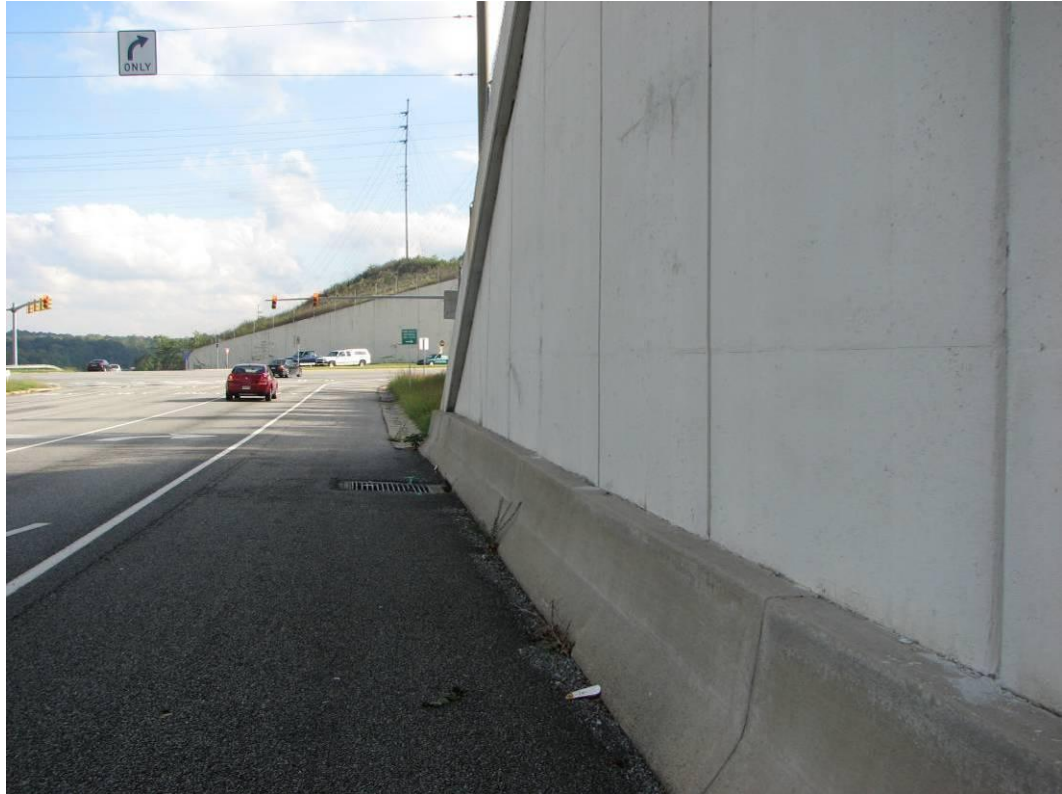
Figure 3.9 - Negative control site in Atlanta. Sample area was the unpainted concrete at the base of the wall.

The site chosen for negative control is the concrete barrier, shown in Figure 3.9, and is located in Cobb County, on the southbound lanes for I-75 for exit 259A to Cumberland Blvd. This ramp was constructed in 1999, and shows the very beginnings of biofilm growth, as seen in Figure 3.10 [69]. No construction coating is covering the concrete. Samples were taken from both the parts of the wall that showed the beginnings of growth as well as the parts that were clean.

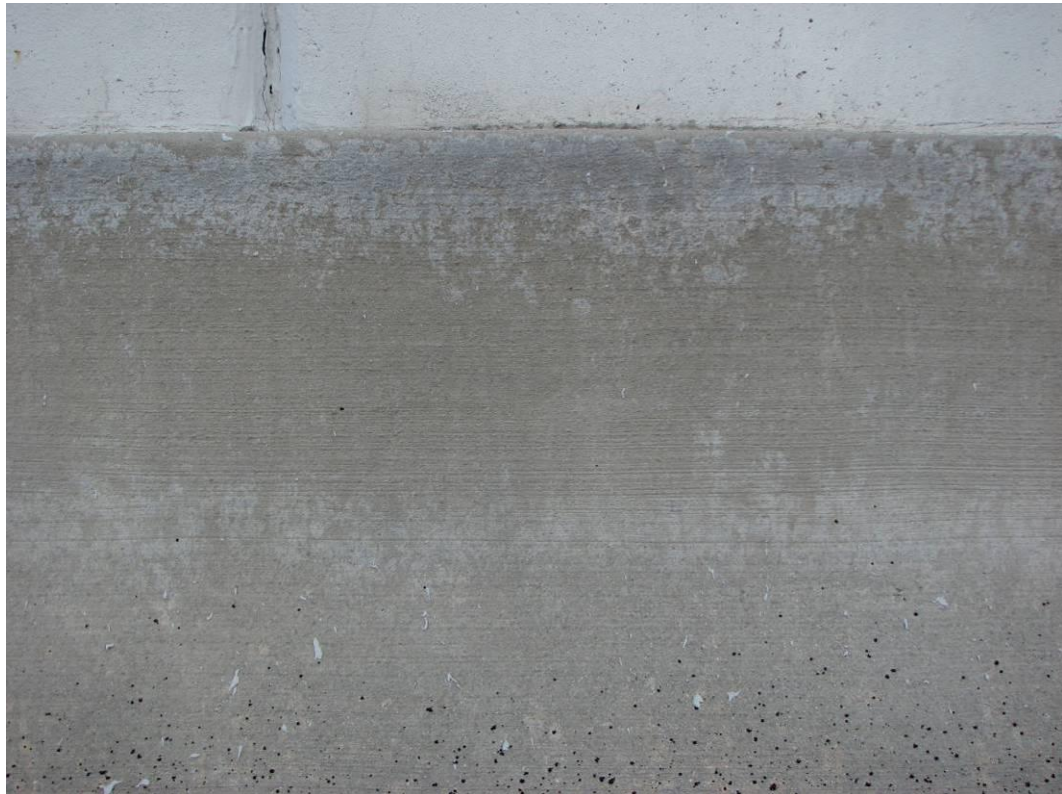
Figure 3.10 – Sample area of concrete wall with no biofilm present

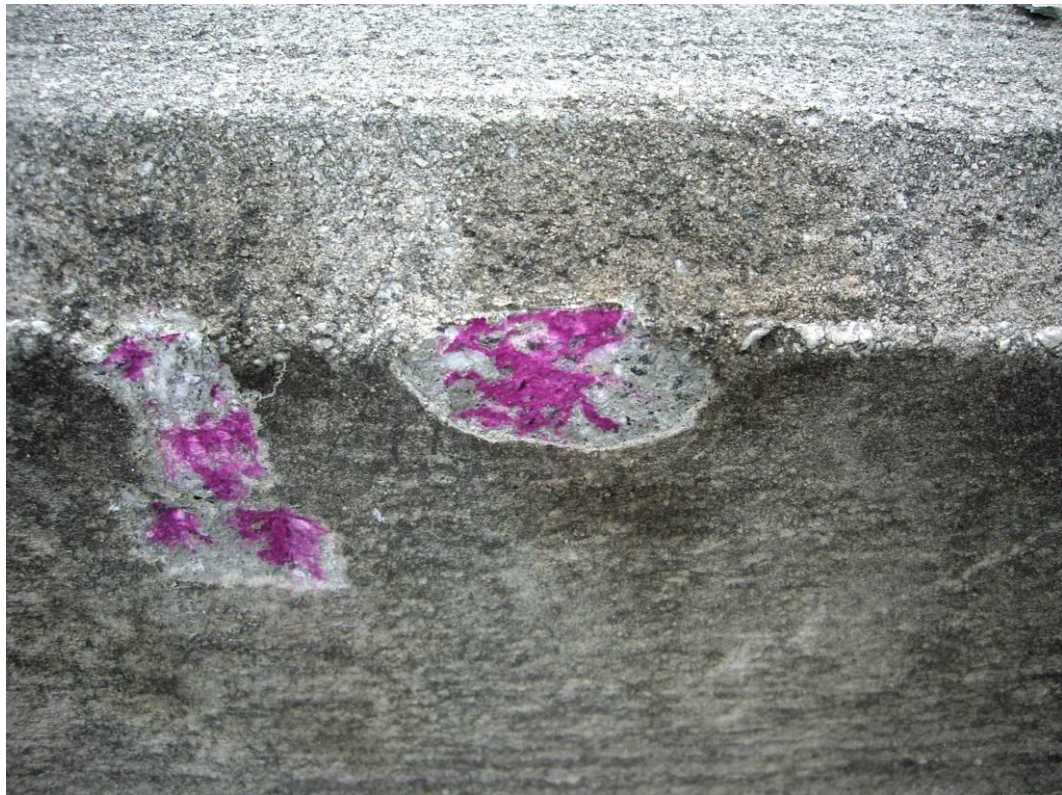
Figure 3.17: Phenolphthalein indicator on freshly chipped surface (field of view ~10 cm)

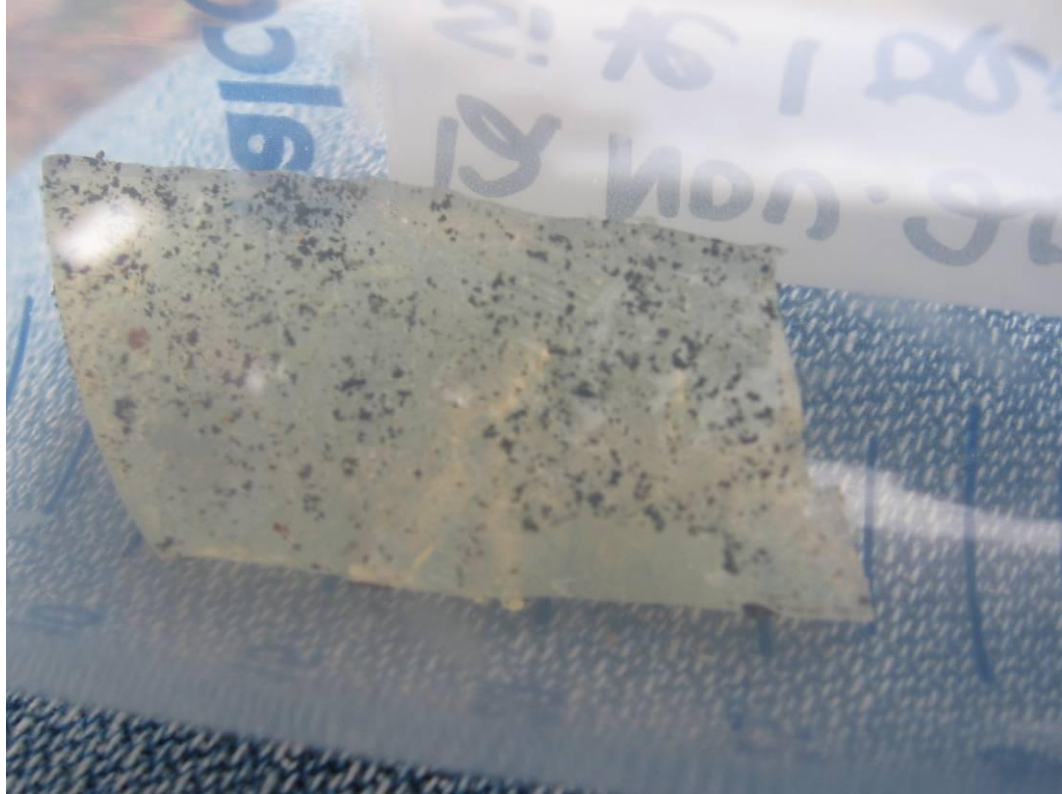
Figure 3.18: Microbial sample on agar strip

Surface samples of the biofilm at each site were collected by adhering various growth media to the concrete surfaces. Three types of media, sabouraud dextrose, malt extract, and nutrient agar were used. Samples were obtained by aseptically pressing strips of agar against the surfaces of the sites which were stored at 4°C until DNA extraction and analysis was performed. Figure 3.18 shows an example of the material collected by this method.

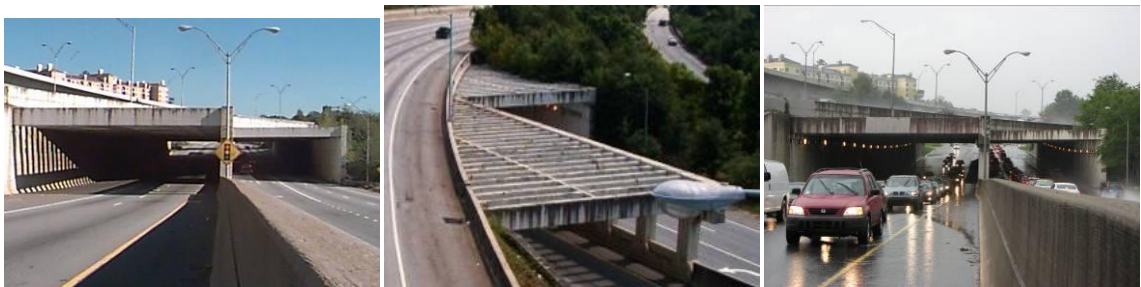
Figure 3.23 – Photos from 1999, 2005, and 2007 for Atlanta

Coverage was visually assessed on concrete structures present in a historic series of photographs. An example of the continuity is shown in Figure 3.25. The visually dark biofilm was manually removed from each photograph and measured using ImageJ software. An example of the measurement technique is seen in Figure 3.27, with the concrete area examined on the left and the biofilm coverage shown on the right. The ratio between the area and area covered is taken to determine coverage.

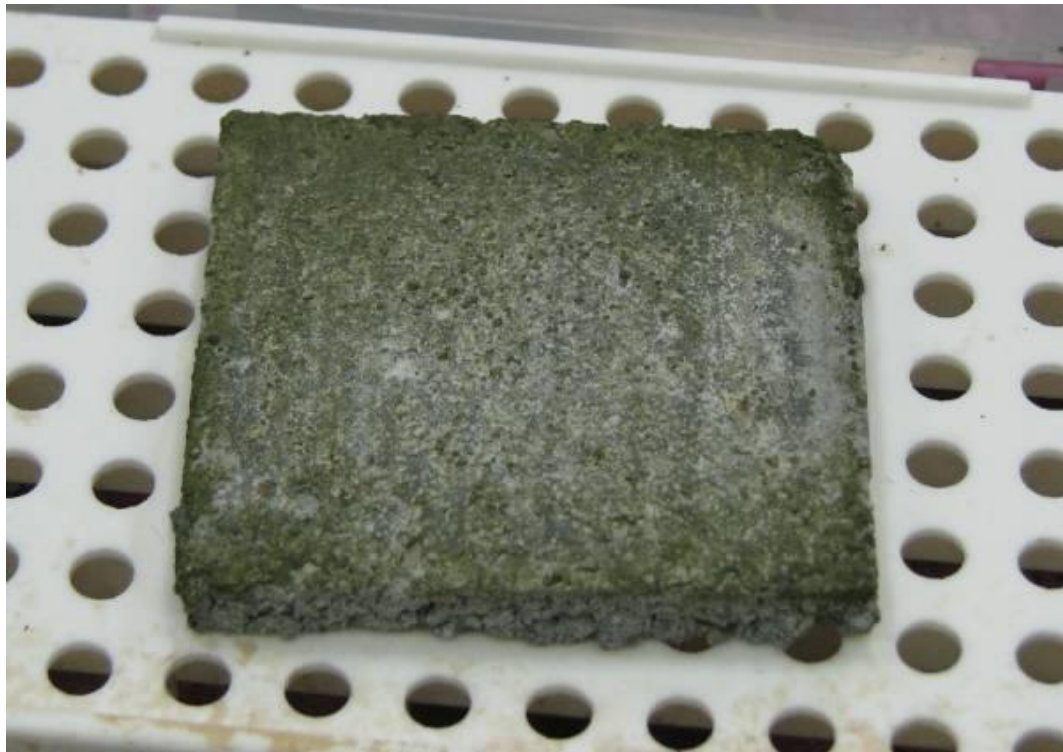
Figure 4.6 – Photo of 3x3 cm tile placed on potato dextrose agar plate

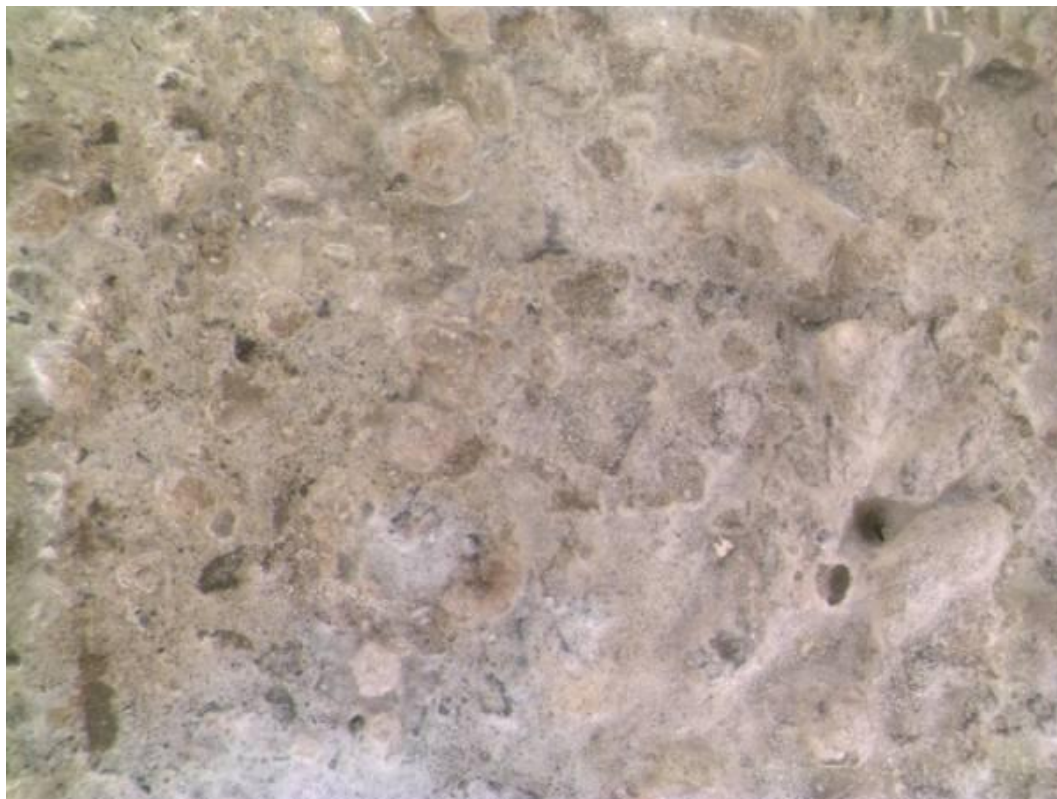
Figure 4.8 – Stereomicroscope image of soft agar and *T. viride*; no growth visible

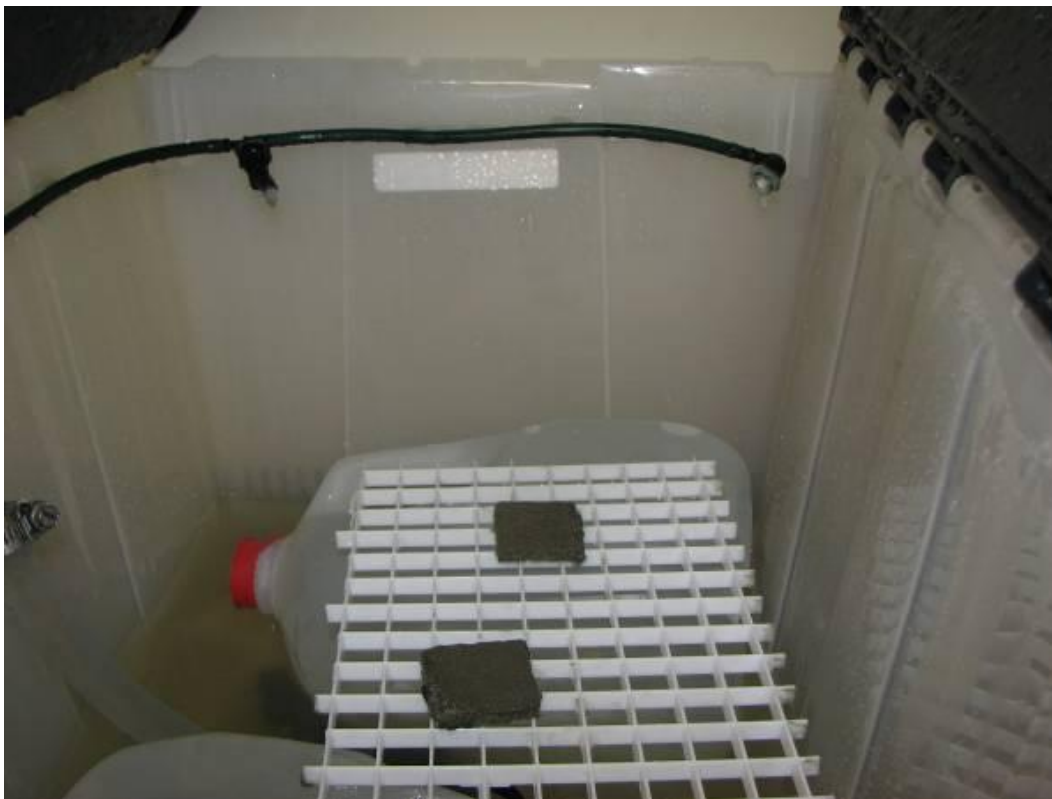
Figure 4.11 - View of Chamber

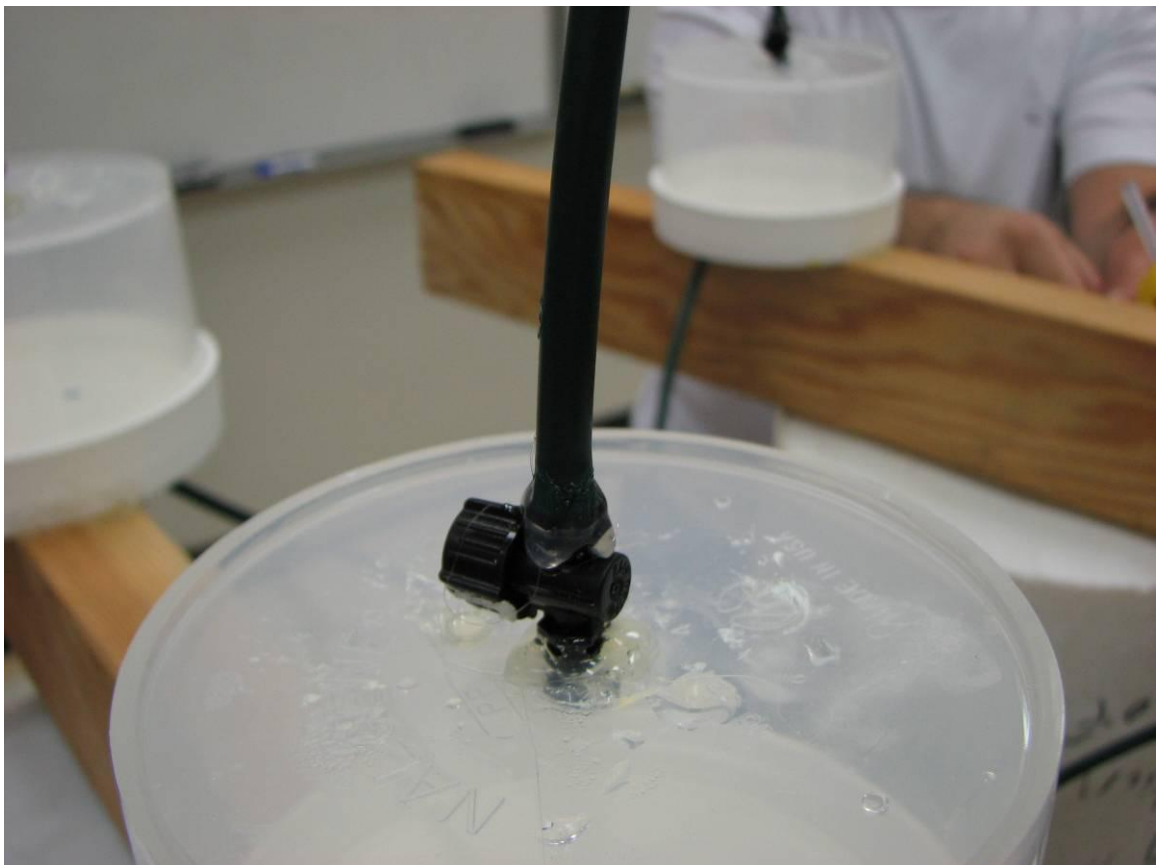
Figure 4.18 - Closeup of penetration sealed with hot glue

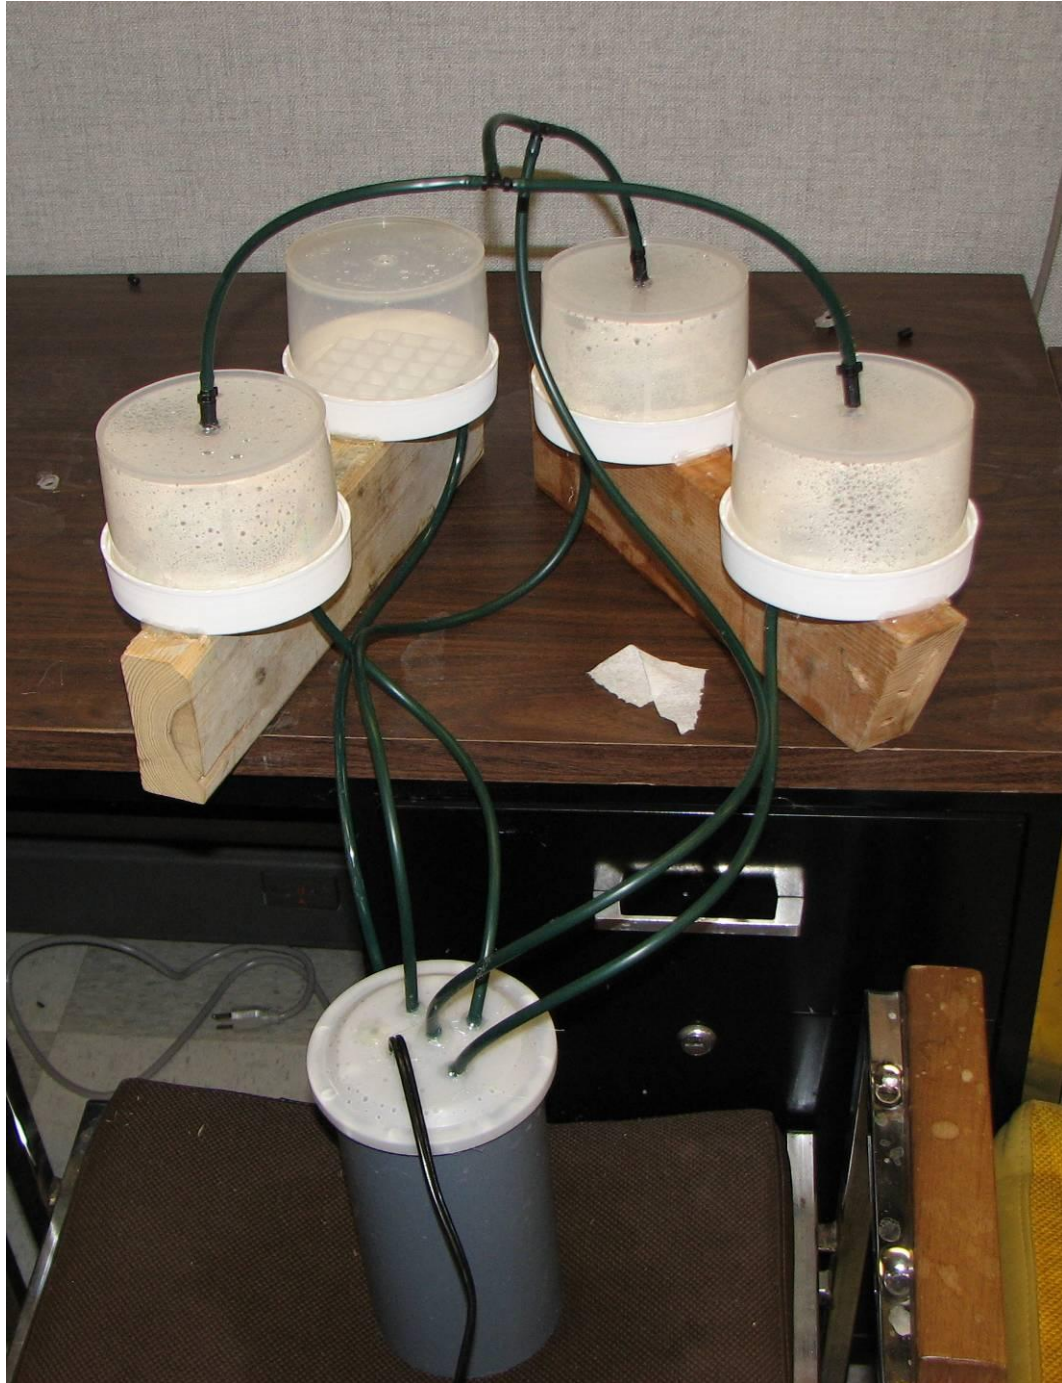
Figure 4.19 - Photograph of system

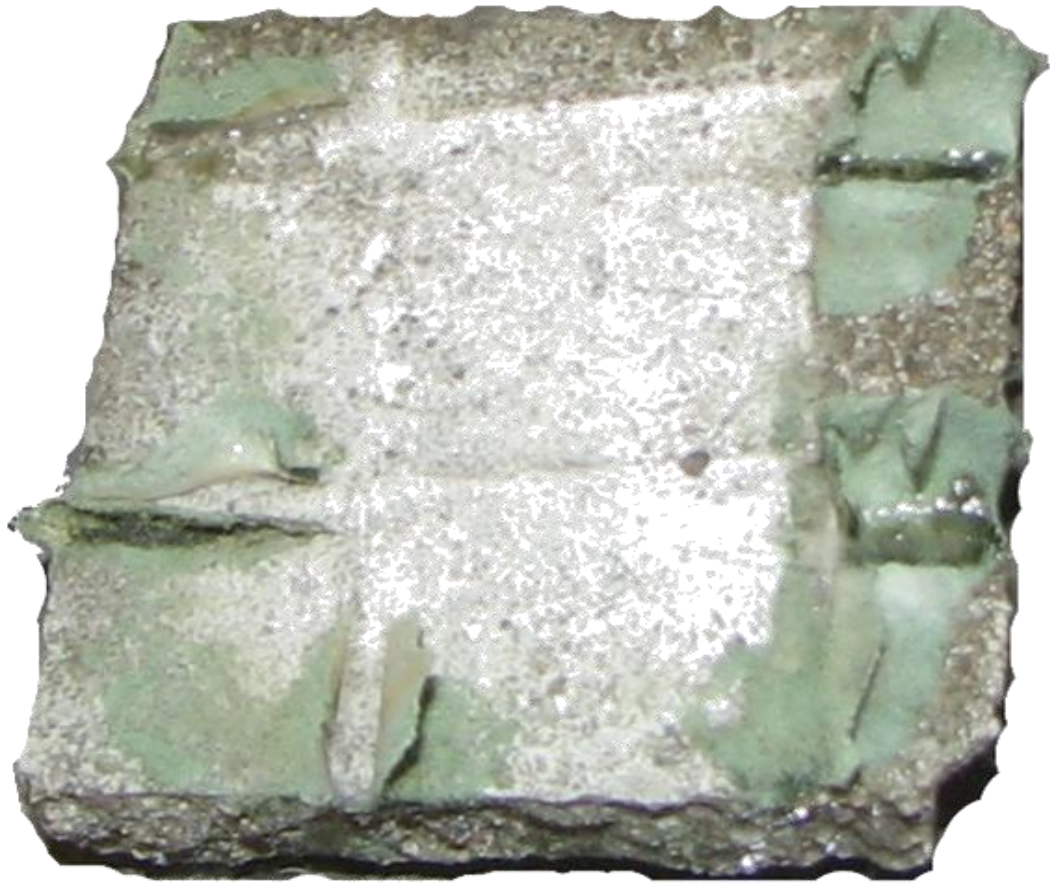
Figure 4.20 - *T. viride* on tile immediately after removal from moist chamber (3x3 cm)

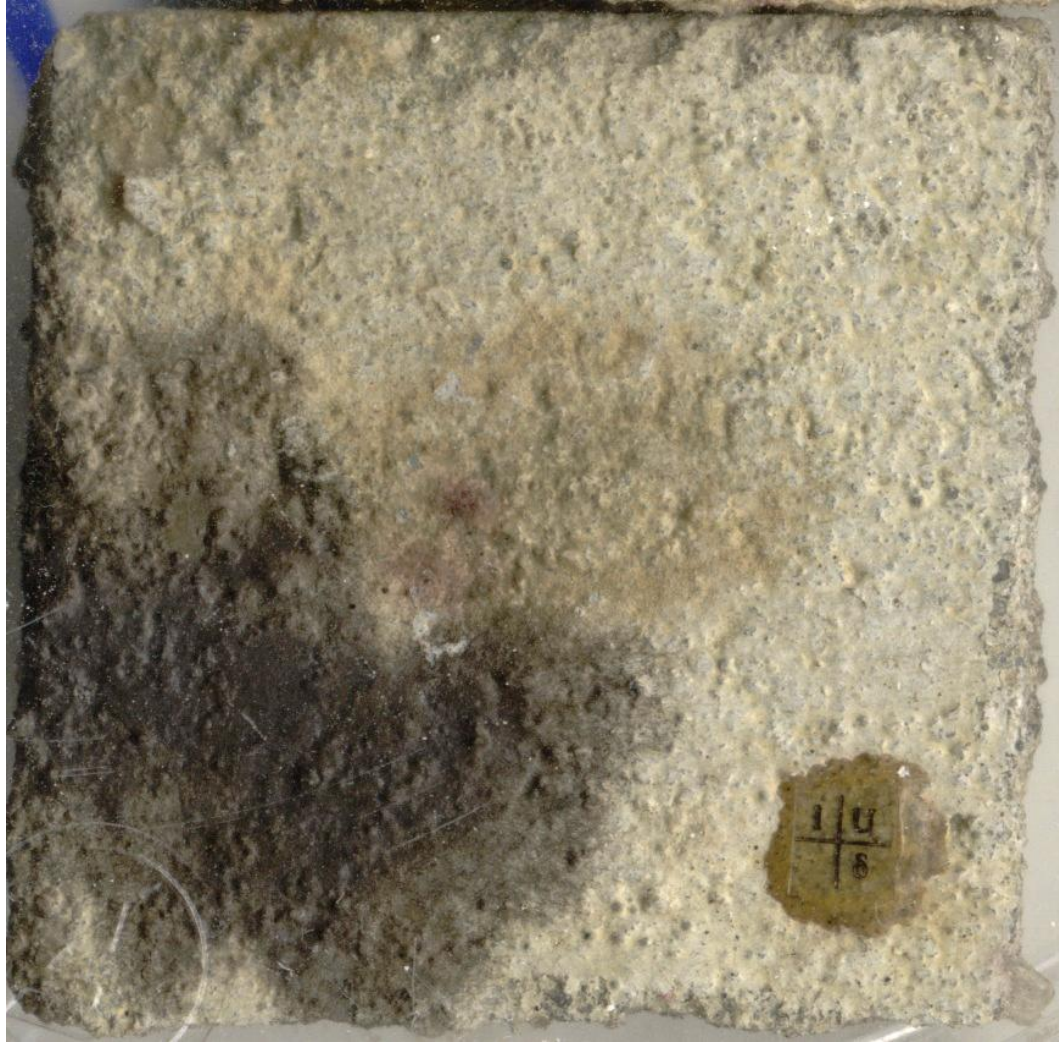
Figure 4.21 - *T. viride* dried on surface after 4 days exposure to 50% relative humidity (3x3 cm)

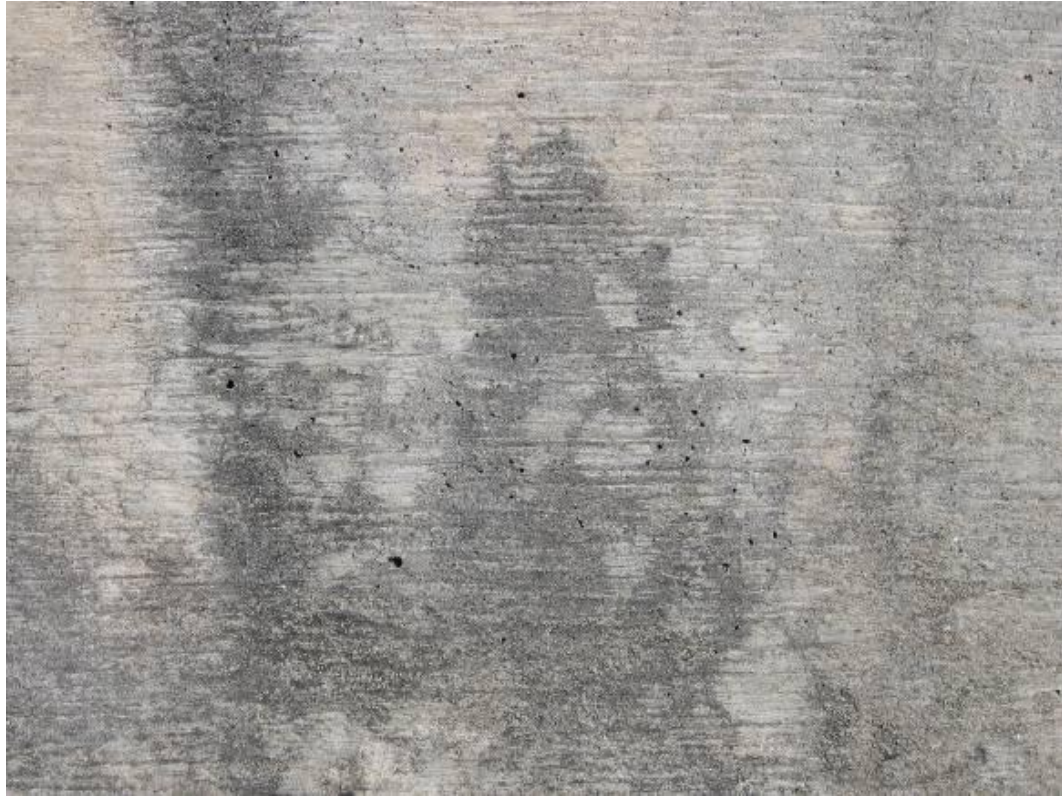
Figure 4.22 - Biofilm at Atlanta site; F.O.V. 20 cm

Atlanta site, shown in Figure 4.22. The hues of the biofilms are different, which can be explained by two reasons. First, the biofilms are grown on different media: potato dextrose broth and an unknown environmental source for the site. Although the potato dextrose broth did not stain the tile, it may provide nutrients that cause the fungus to appear a different color. Second, the choice of media could be biased for certain microbes. If the proportion of one species to another is not the same as the field, the biofilm may again appear a different hue.

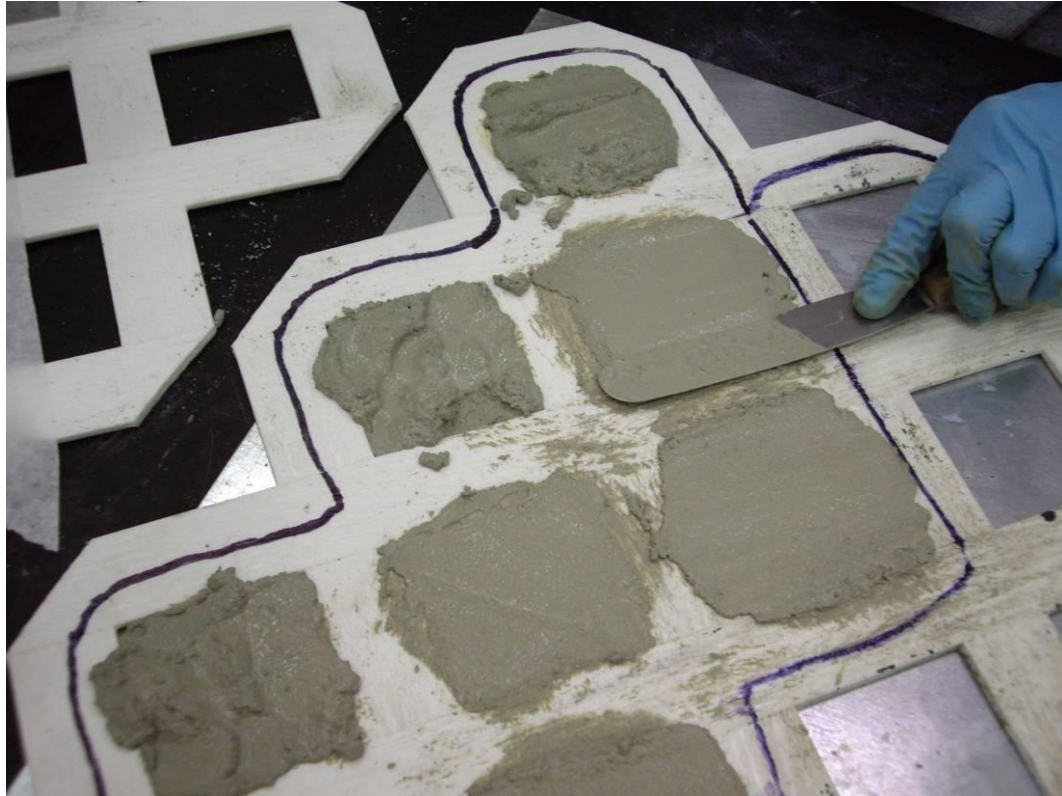
Figure 5.2 - Casting mortar tiles on metal and plastic formwork

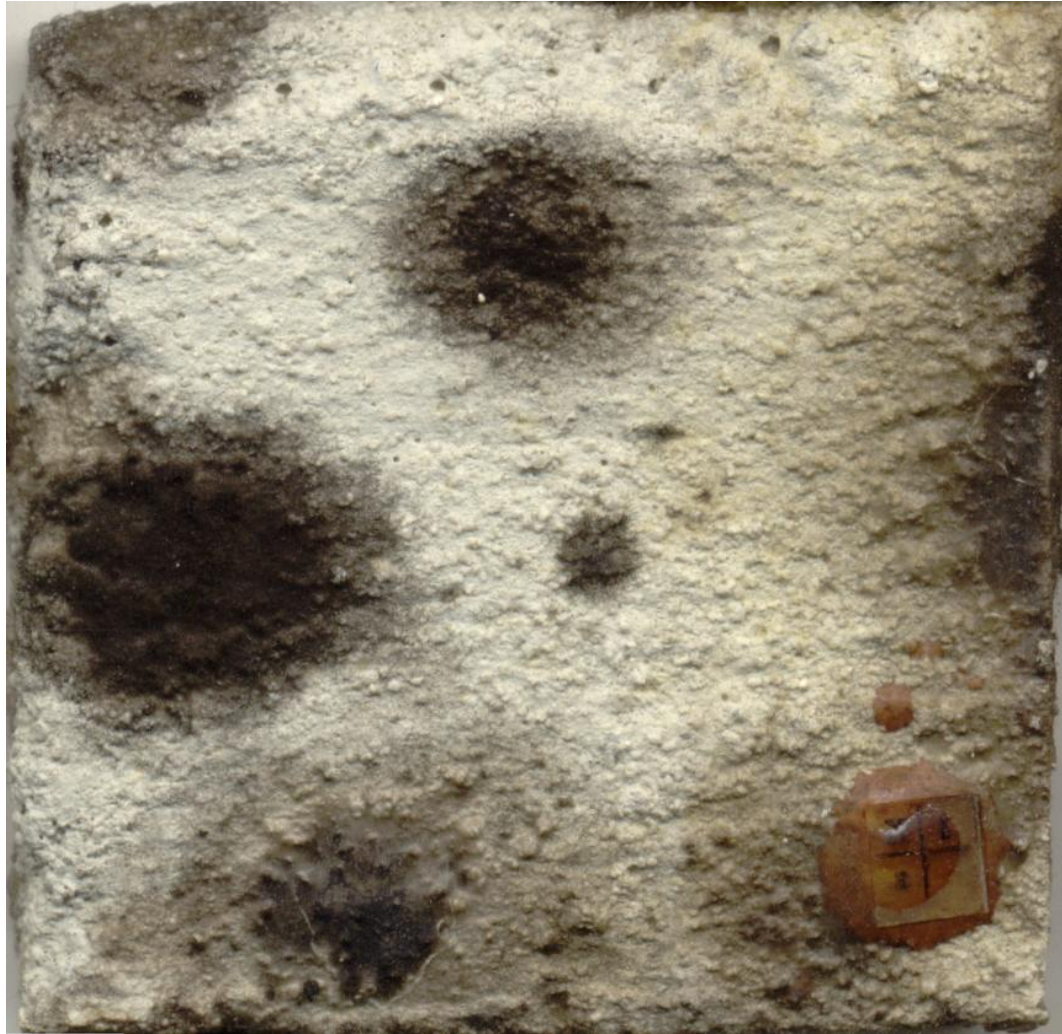
Figure 5.26 - Tile with acrylic coating, inoculated with Atlanta microbes
